Wascana Centre Authority

Comprehensive Review Project

Building and Infrastructure Assessments

September 2012

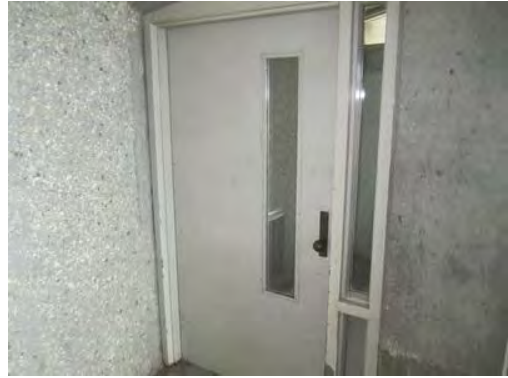
Int Steel Door

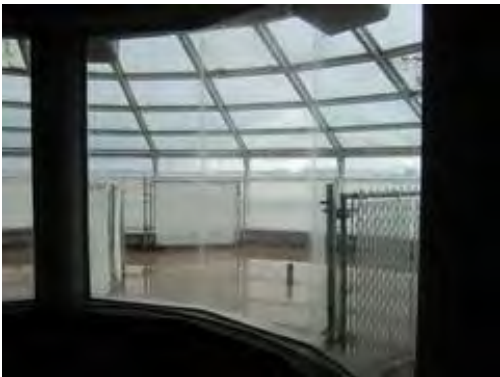
Int Windows

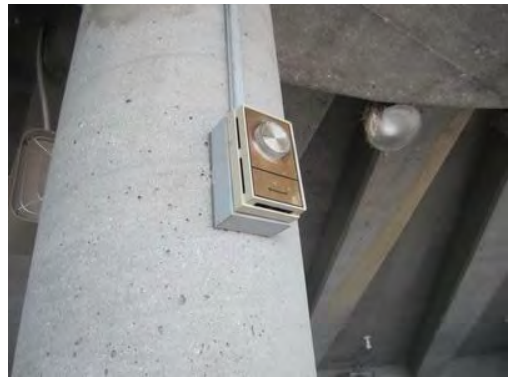
Manual Thermostat

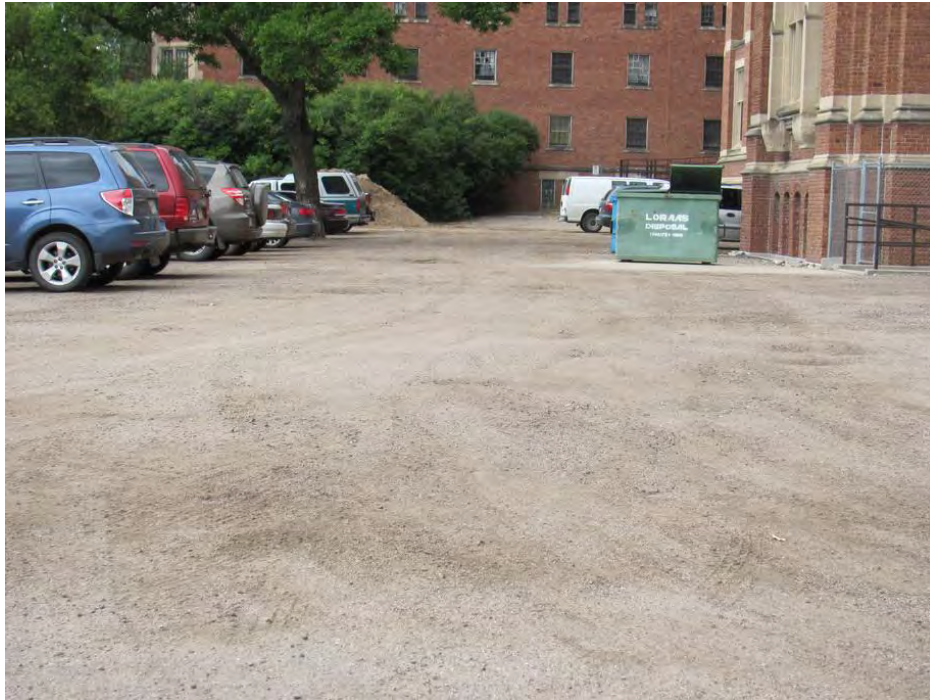
PCI 54 - Parking Lot

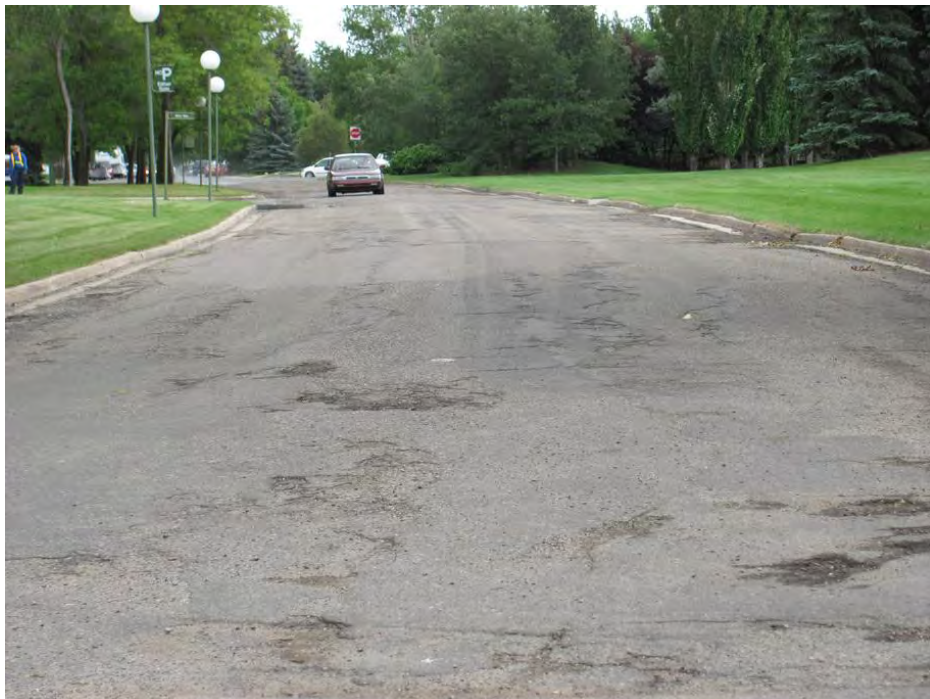
PCI 56 - Road

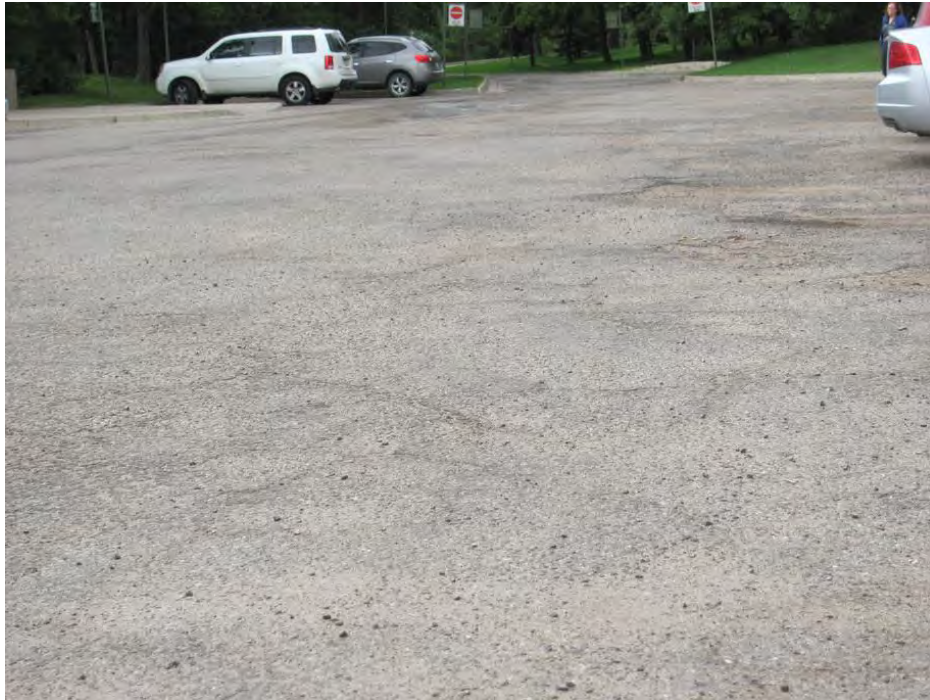
PCI 63 - Parking Lot

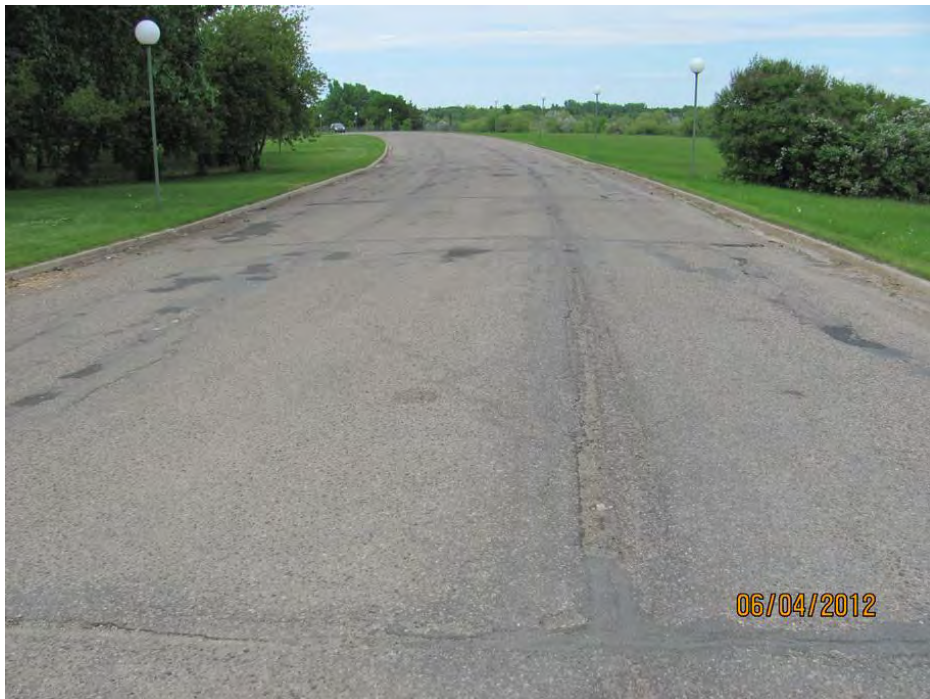
PCI 65 - Road

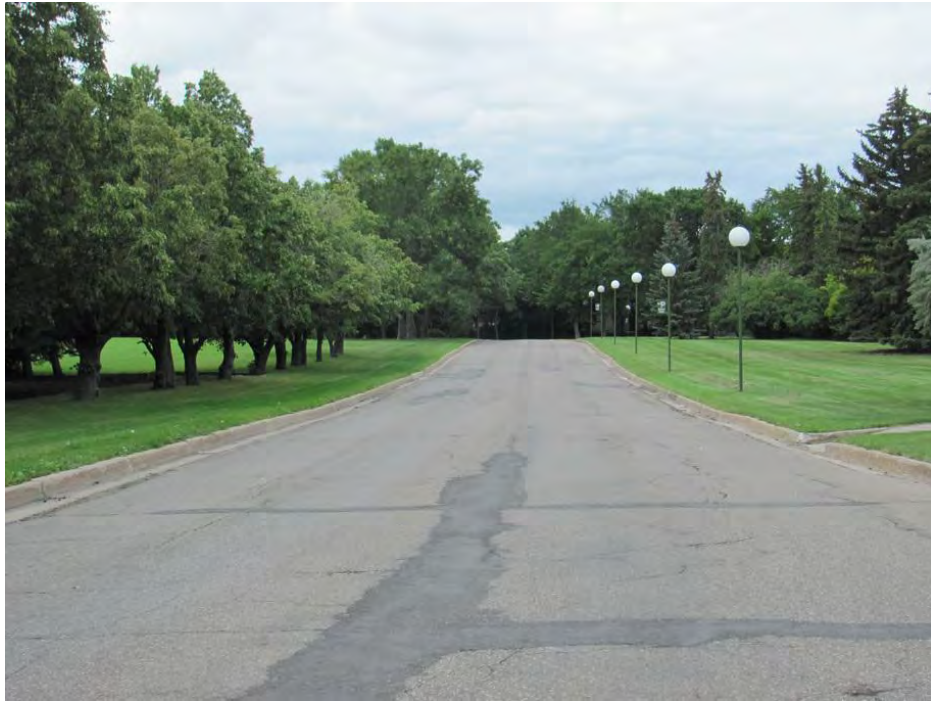
PCI 66 - Road

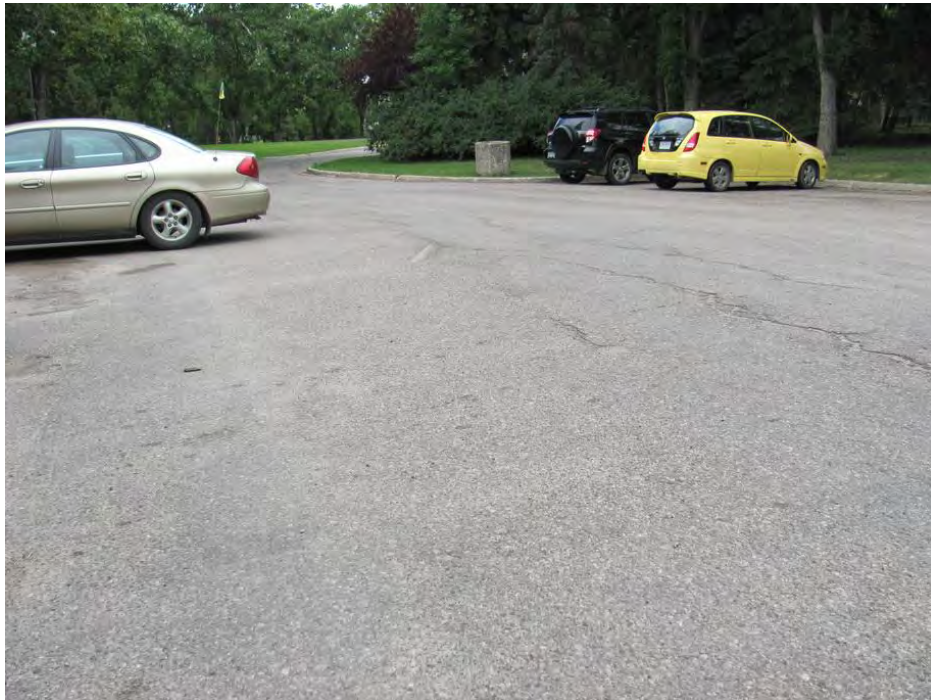
PCI 67 - Parking Lot

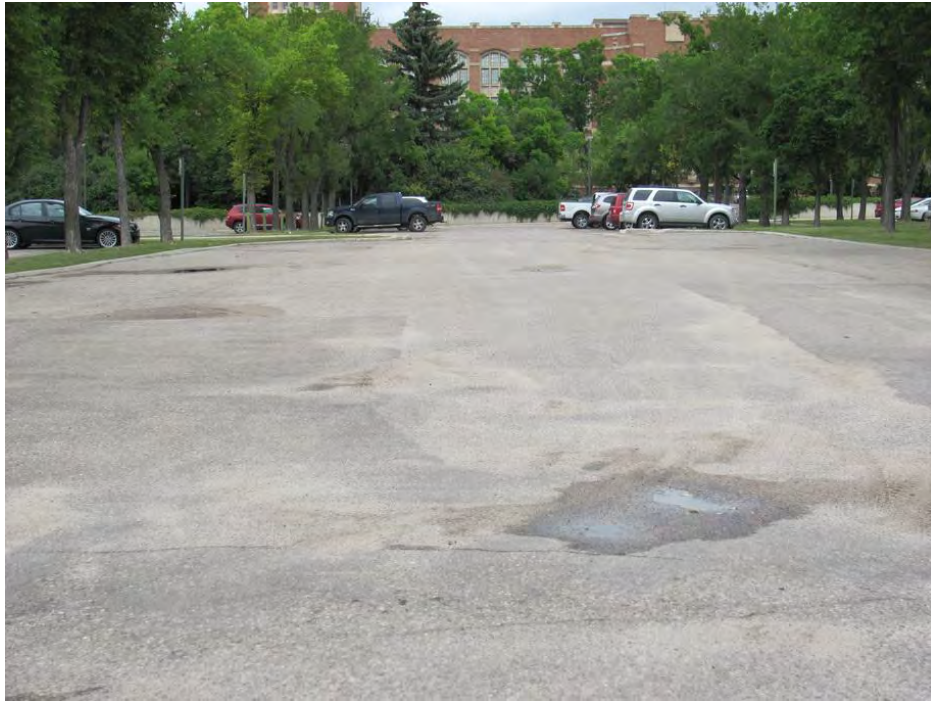
PCI 74 - Parking Lot

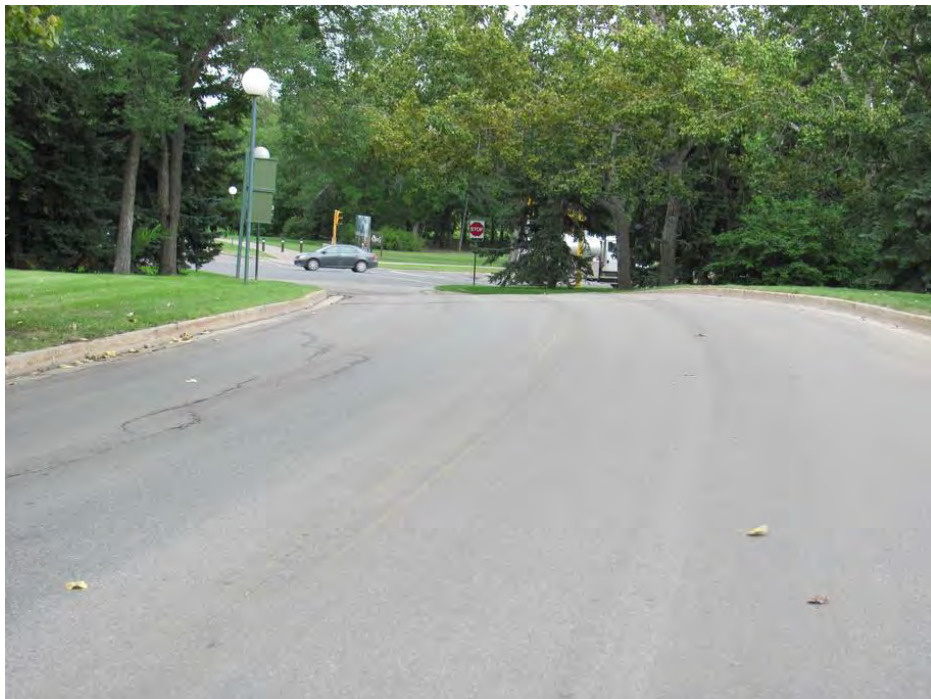
PCI 75 - Road

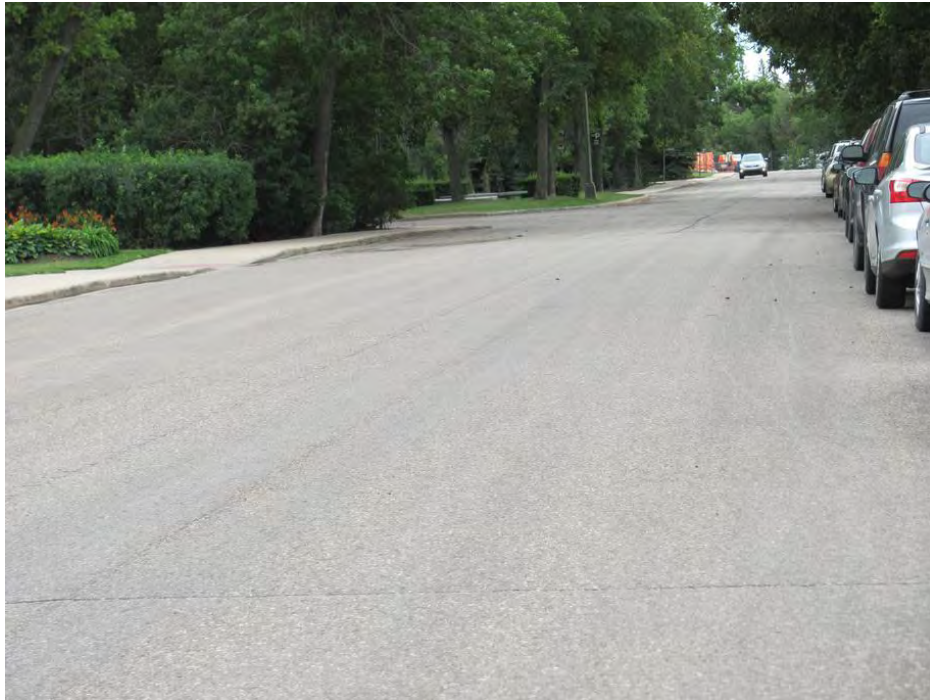
PCI 76 - Road

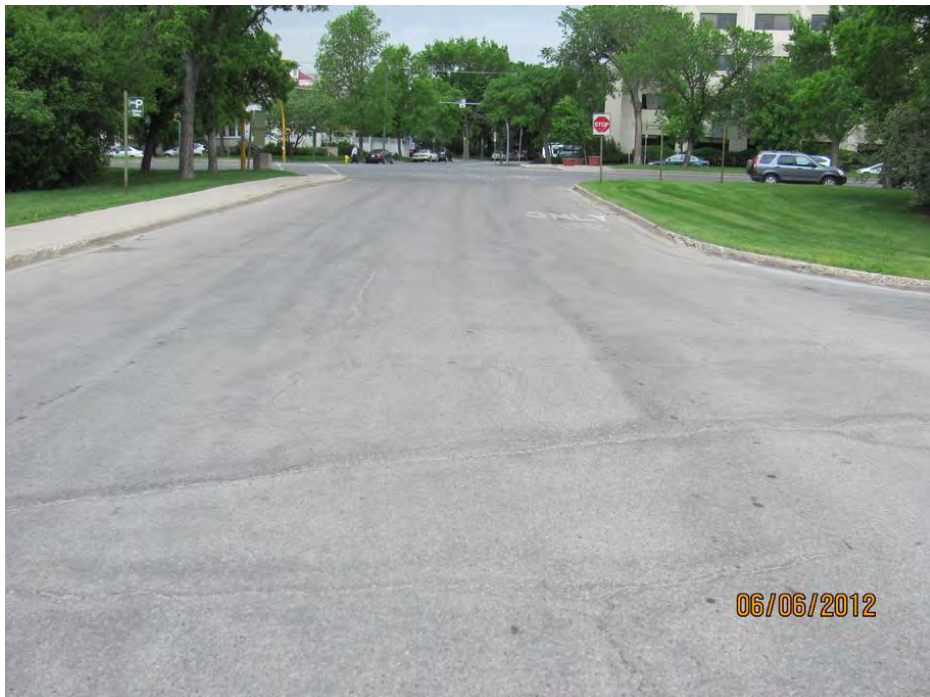
PCI 79 - Road

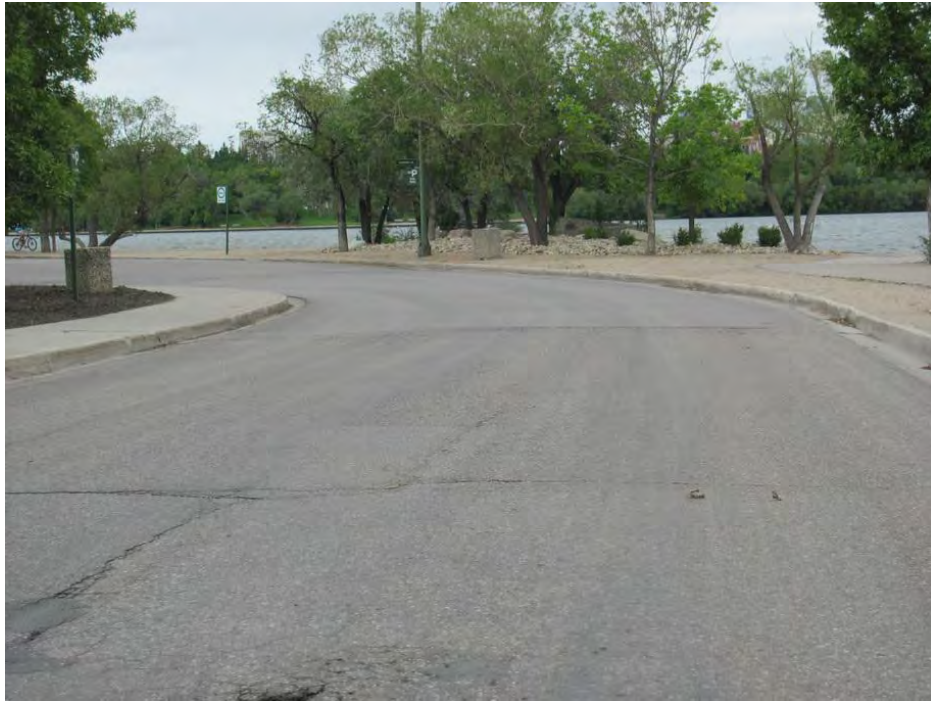
PCI 82 - Road

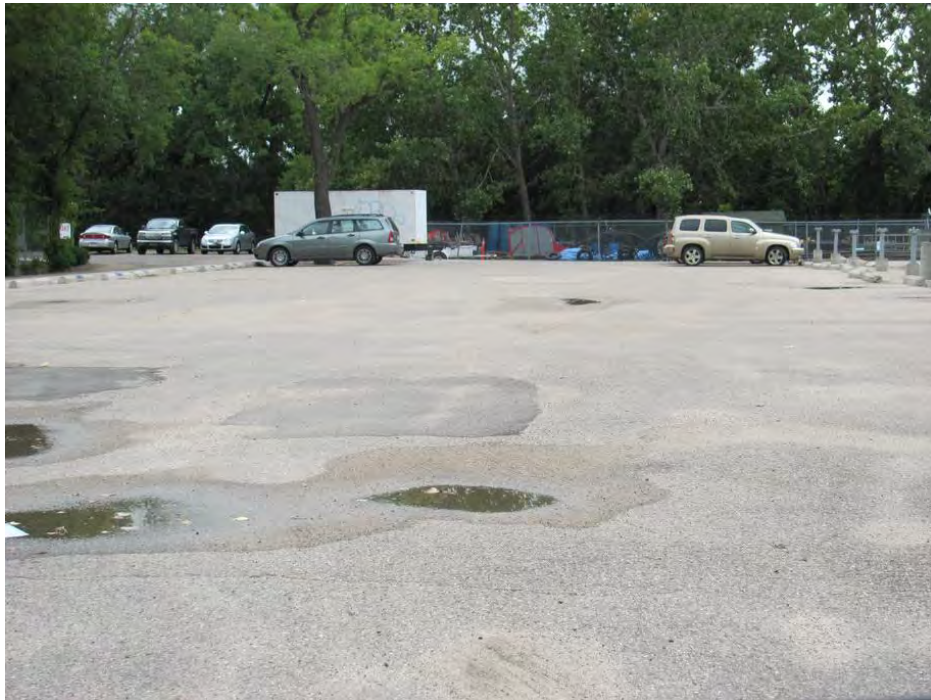
PCI 88 - Parking Lot

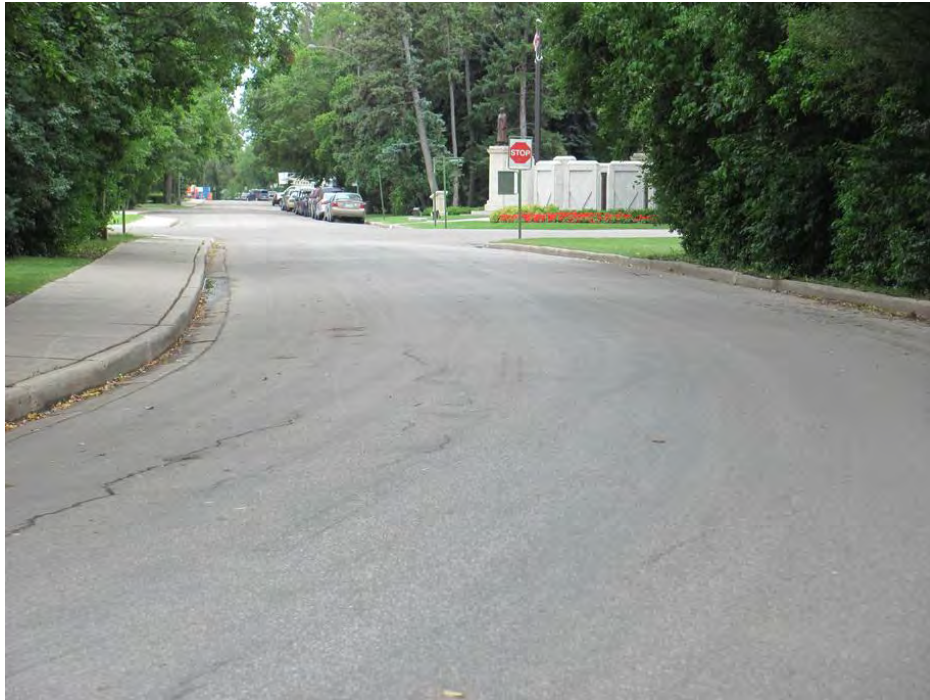
PCI 94 - Road

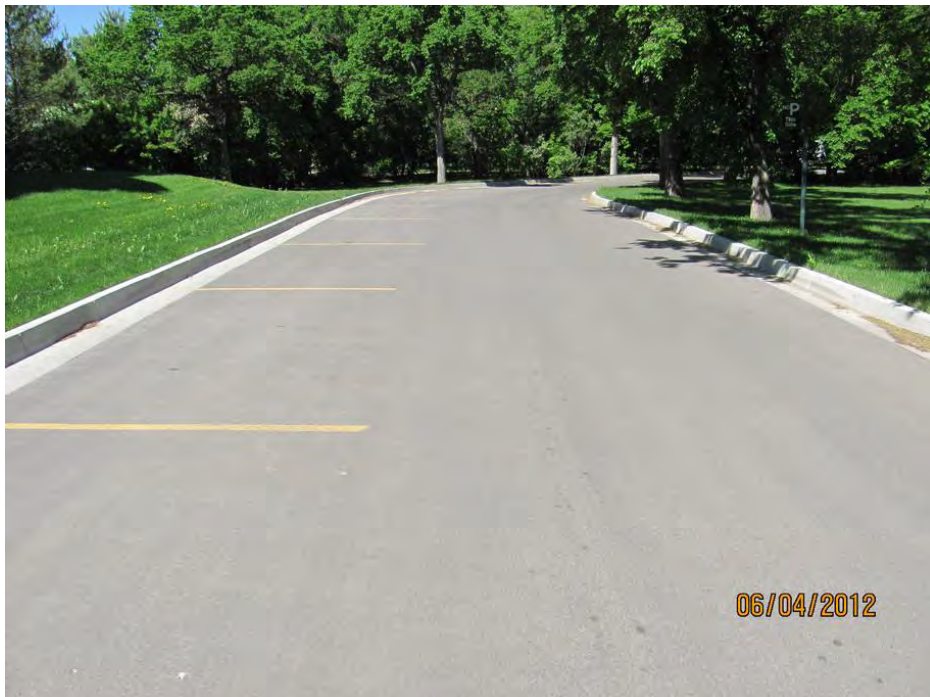
PCI 98 - Road

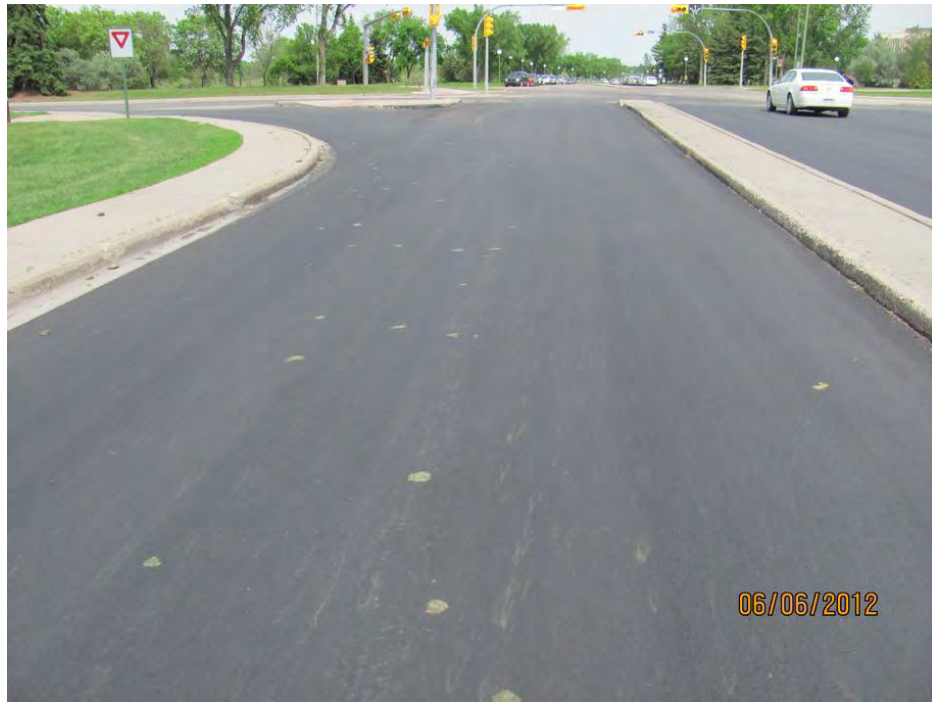
PCI 100 - Road

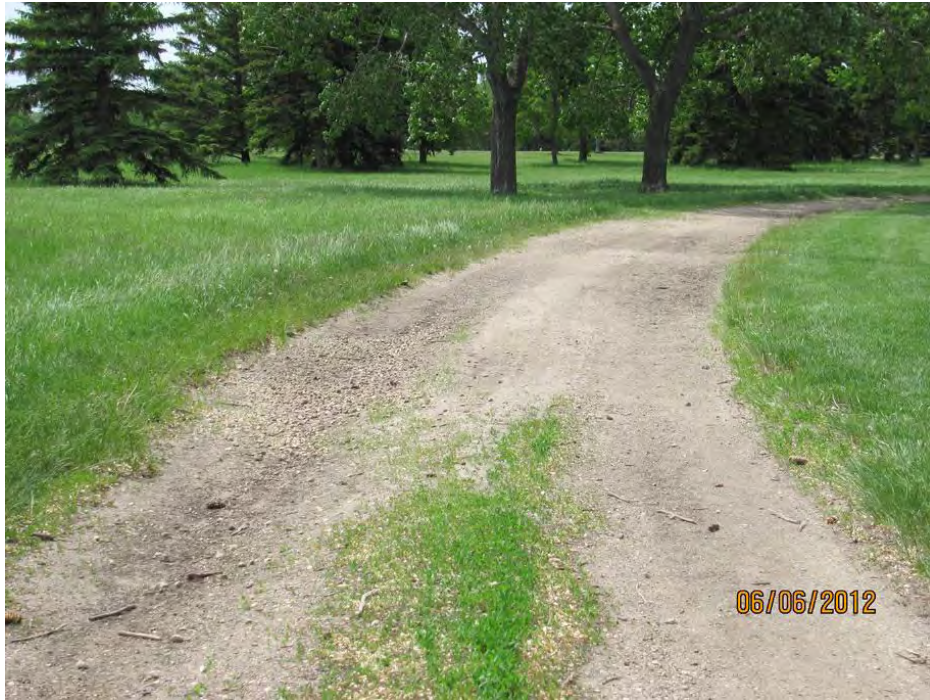
Condition 2 - Path

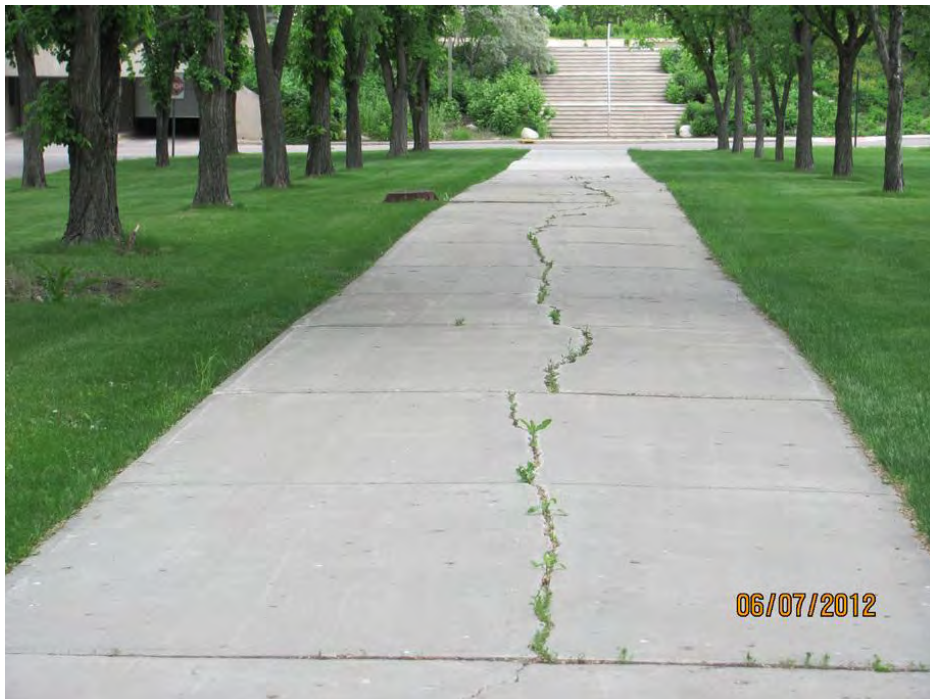
Condition 2 - Sidewalk

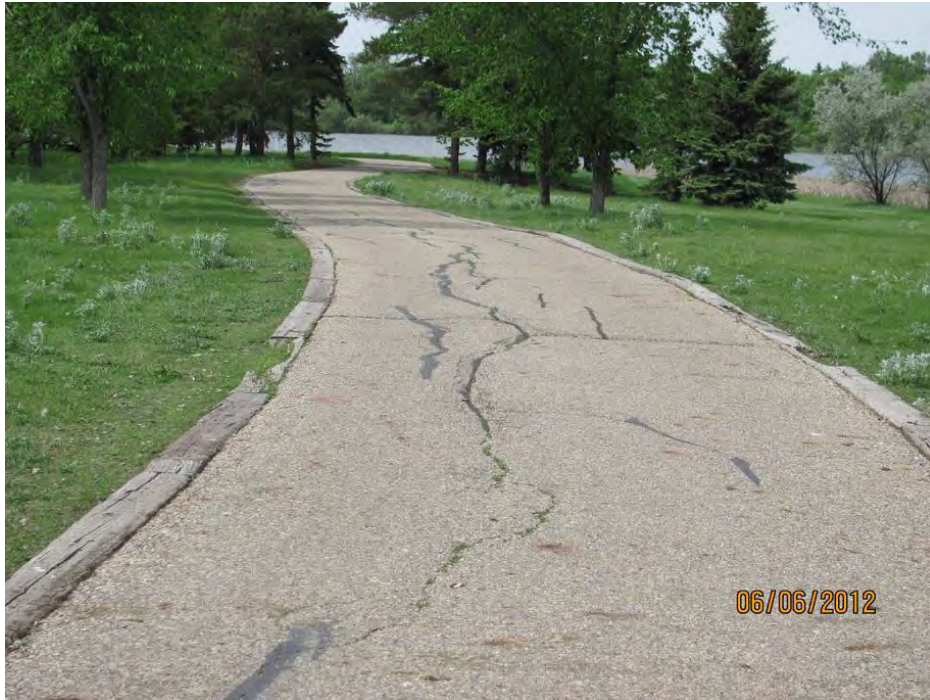
Condition 3 - Sidewalk

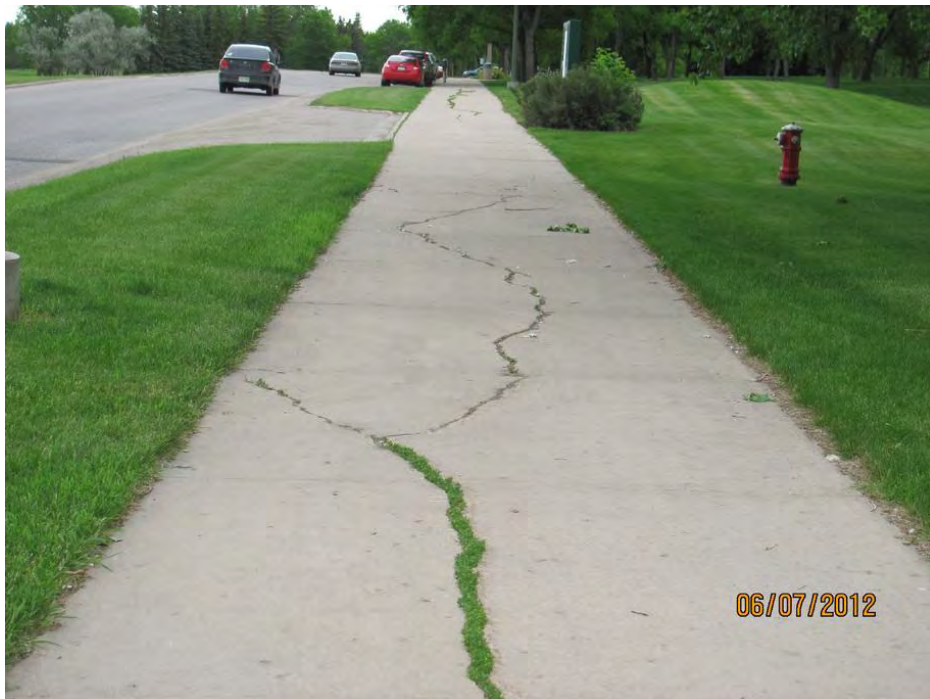
Condition 3 - Sidewalk

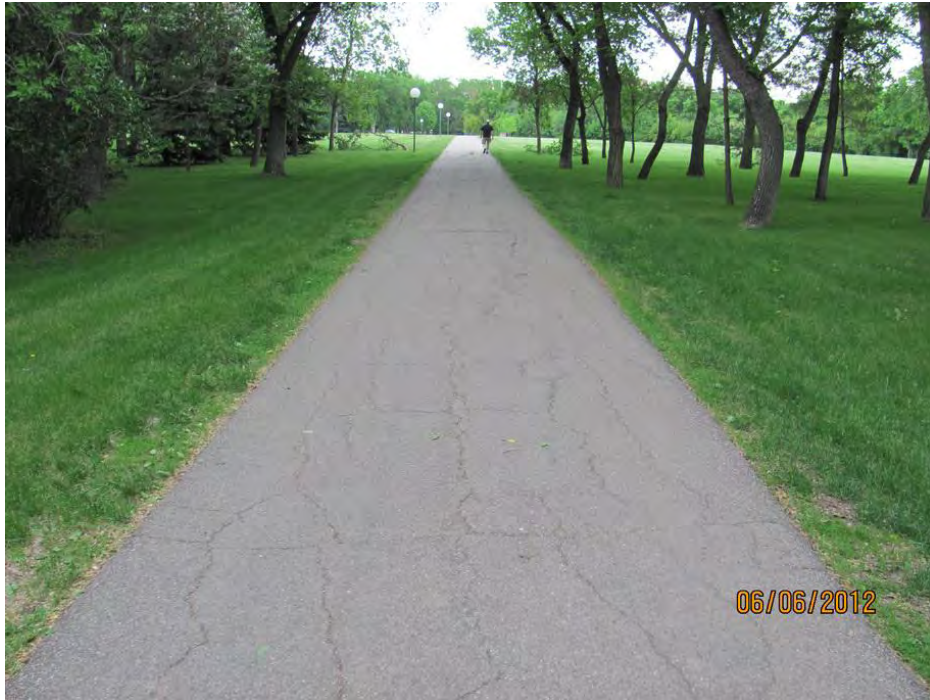
Condition 4 - Path

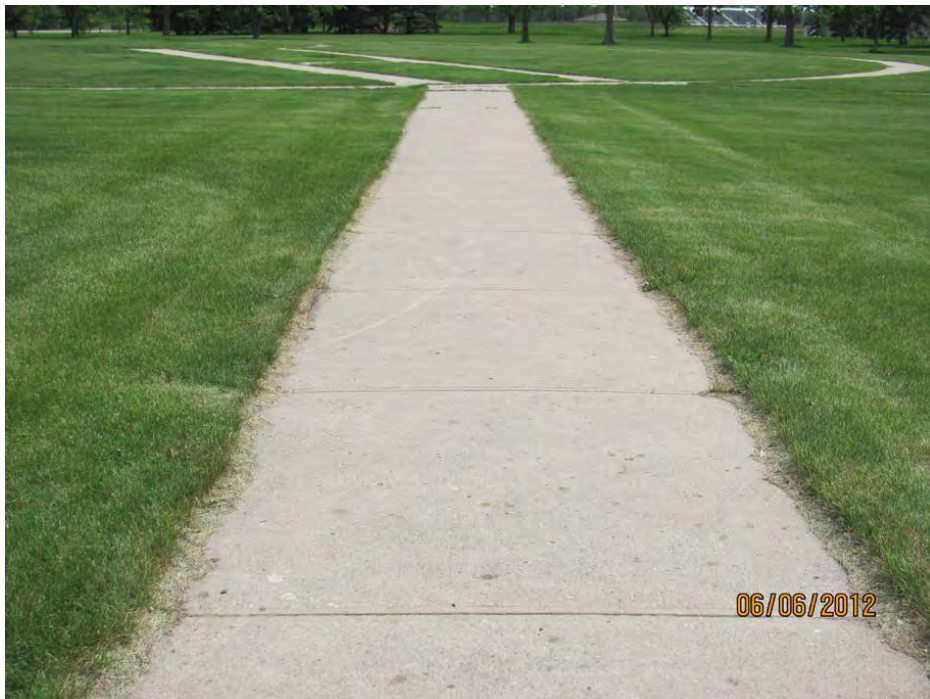
Condition 4 - Sidewalk

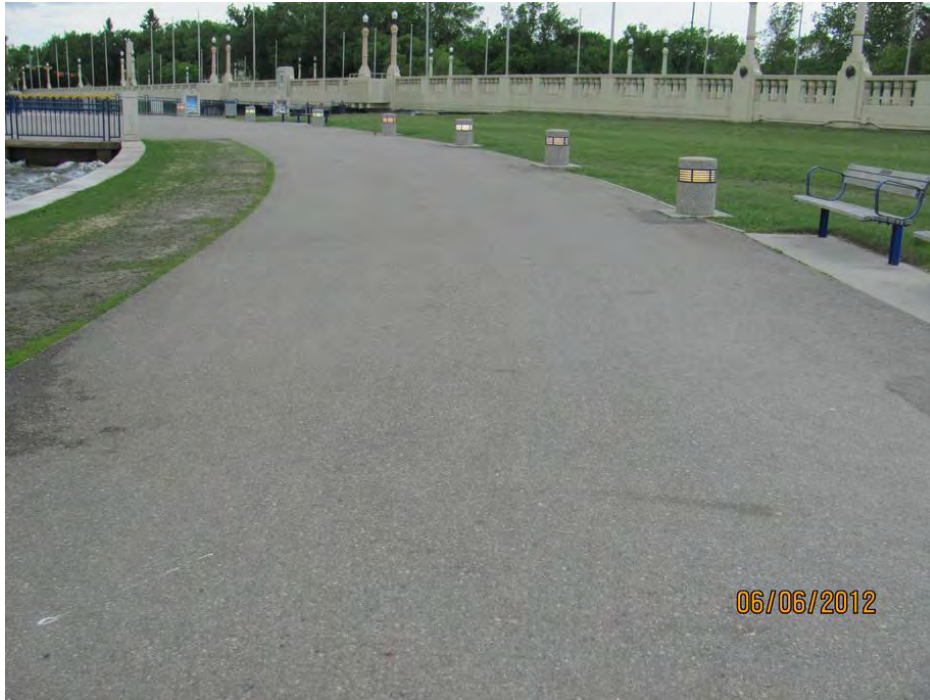
Condition 5 - Path

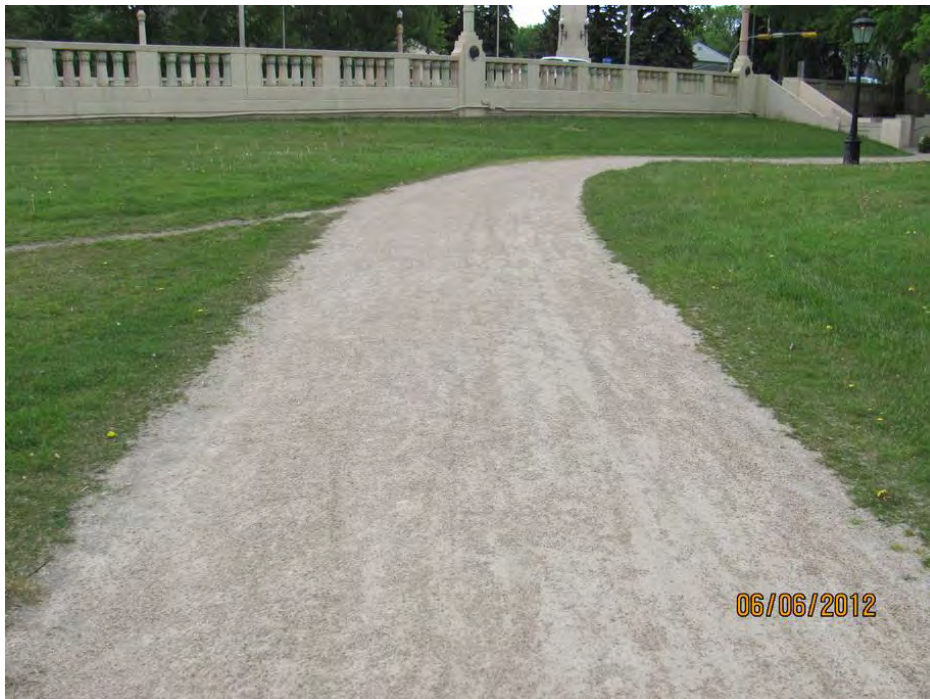
Condition 5 - Path

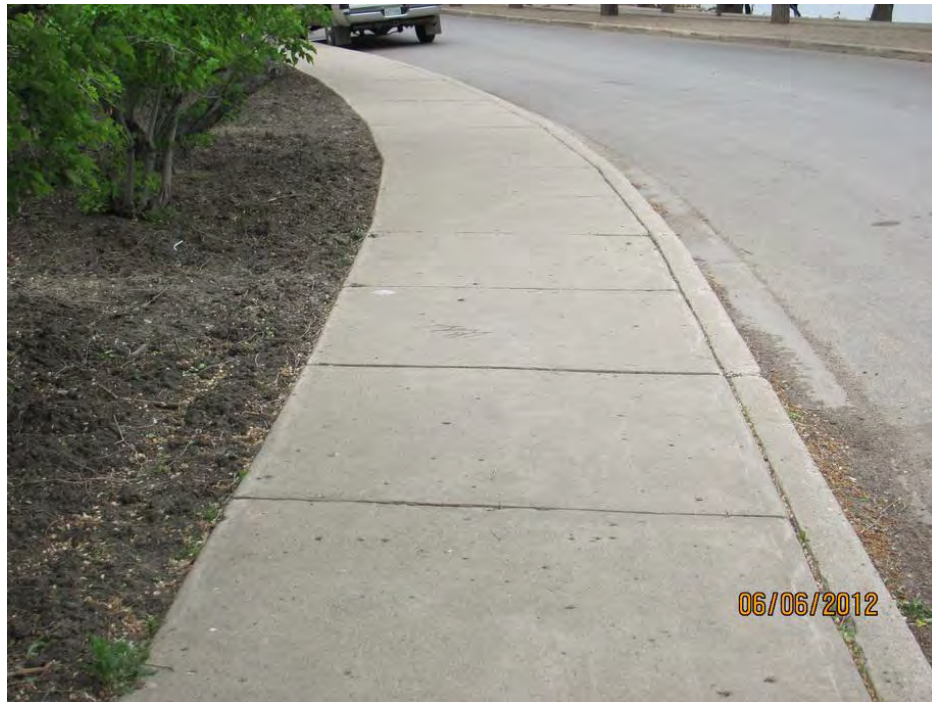
Condition 5 - Sidewalk

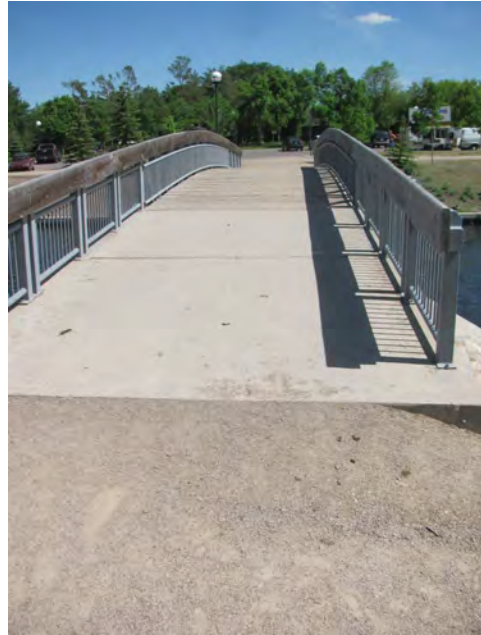
ApproachRoad2-Detail-Exterior

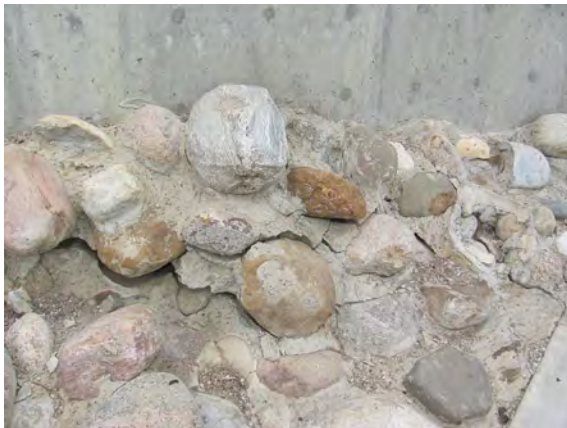
GroutedRiprap-Detail-Exterior

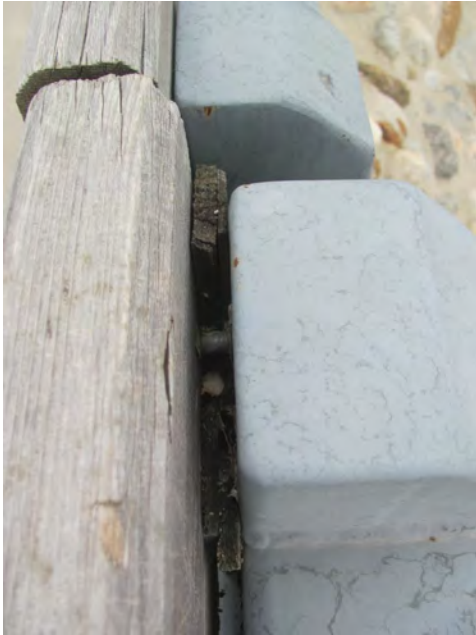
RailFastener-Detail-Exterior

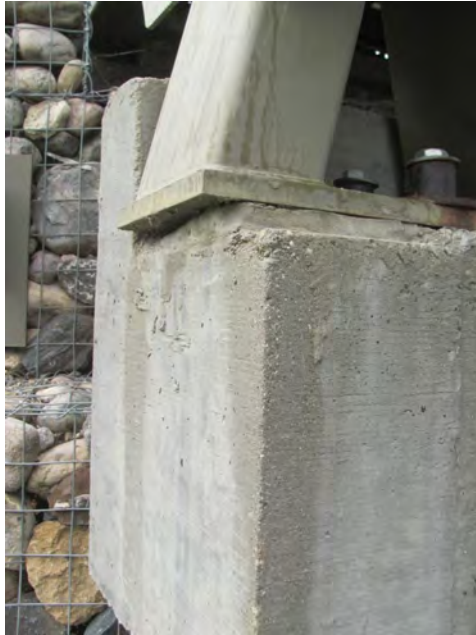
Abutment1Bearing-Detail-Exterior

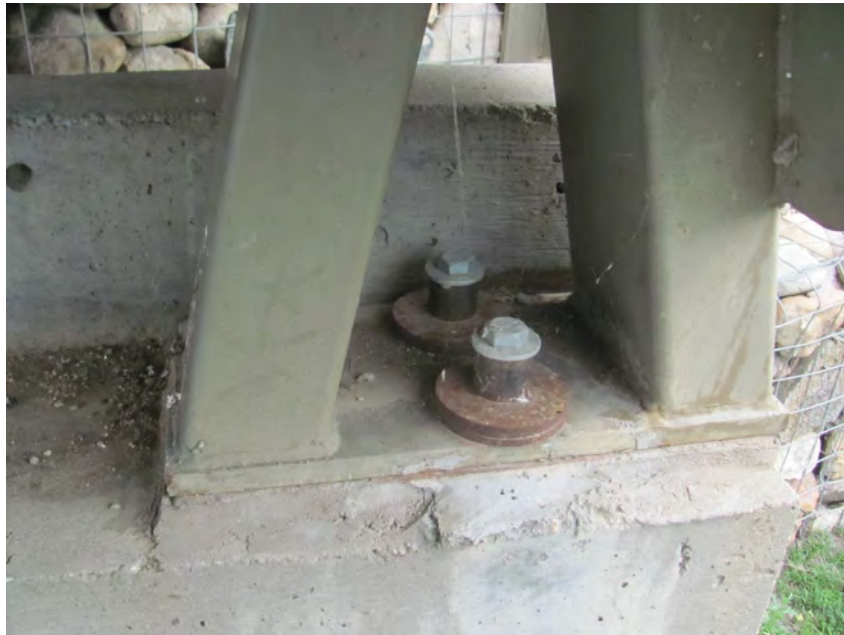
Abutment2Bearing_Detail-Exterior2

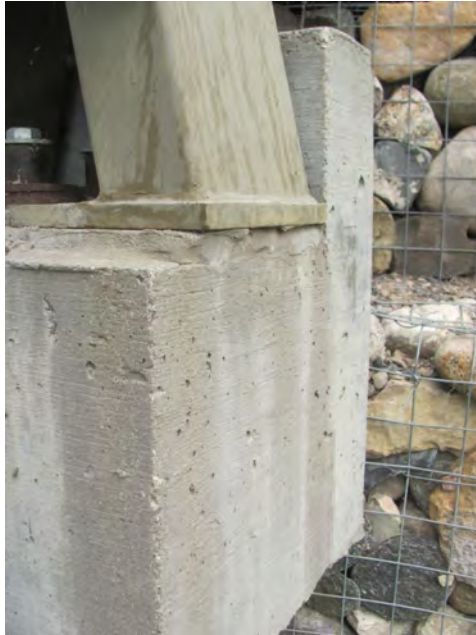
Abutment2Bearing-Detail-Exterior

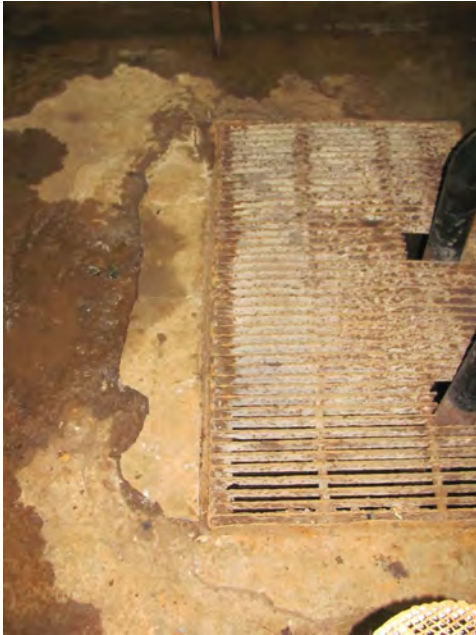
Floor-Detail-Interior

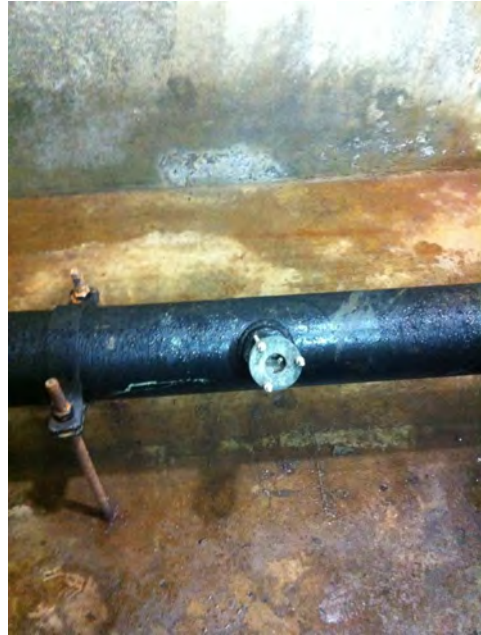
Instrumentation Ports-Detail-Interior

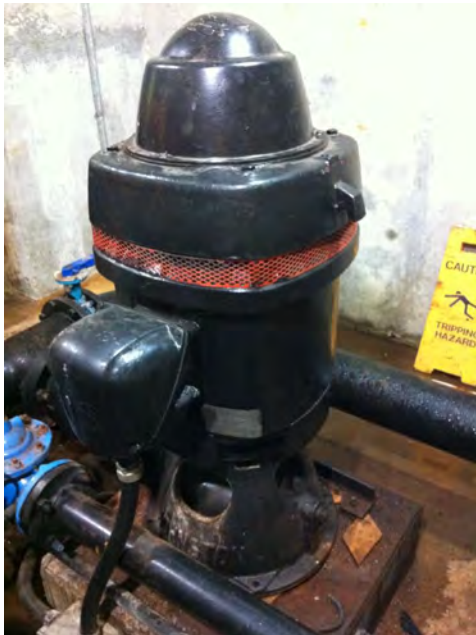
Pump 1-Detail-Interior

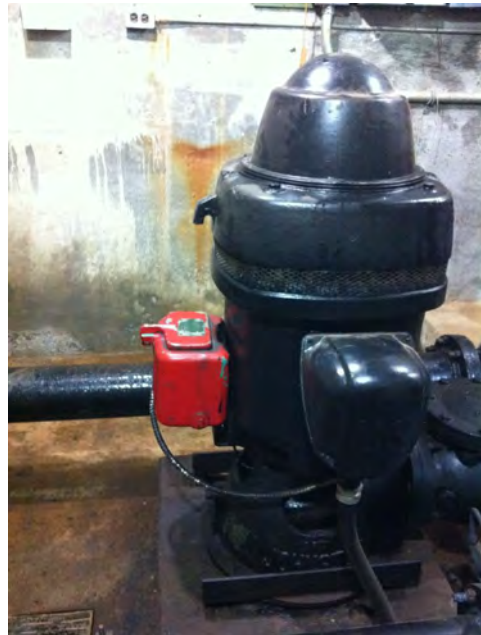
Pump 2-Detail-Interior

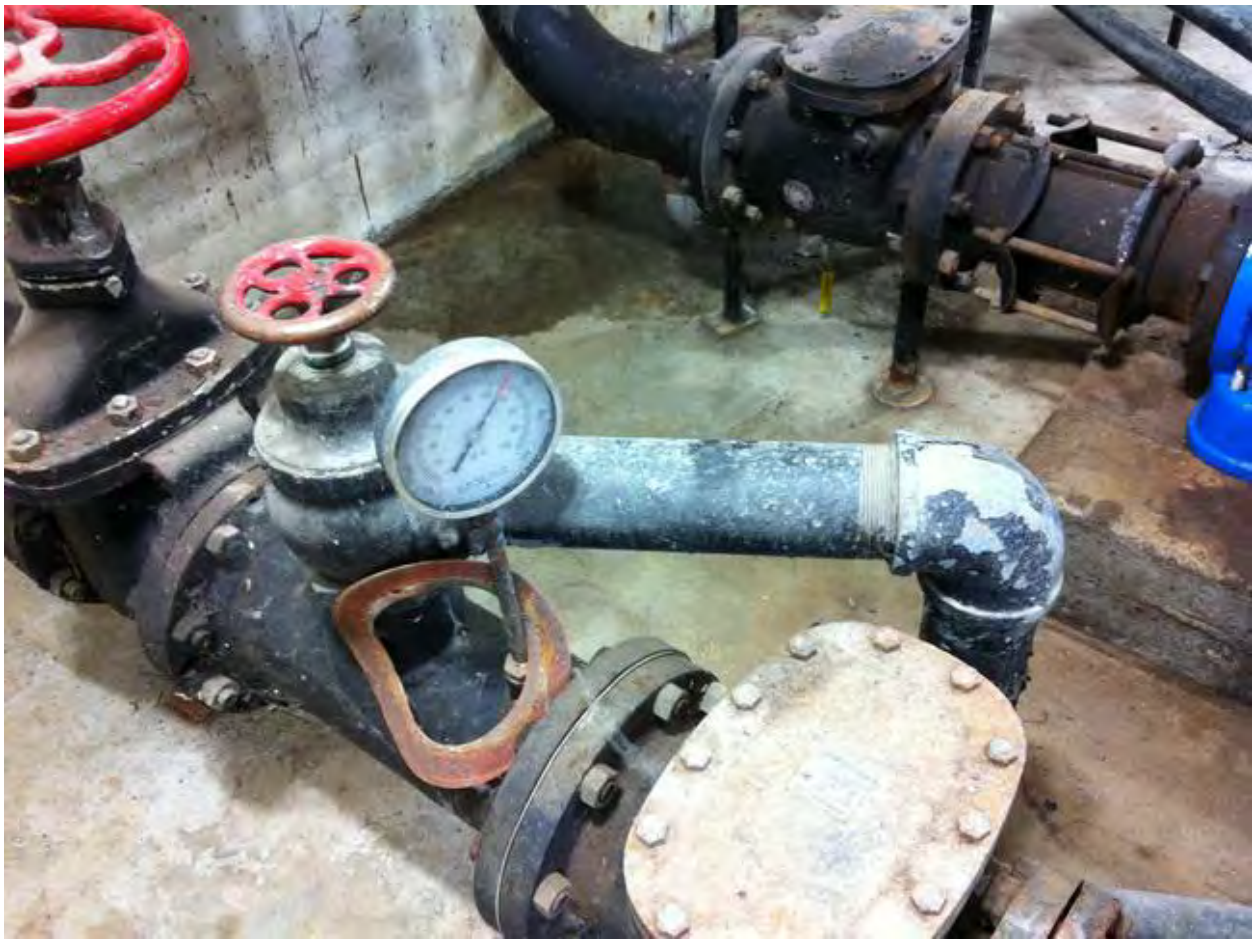
Pressure Relief Valve-Detail-Interior

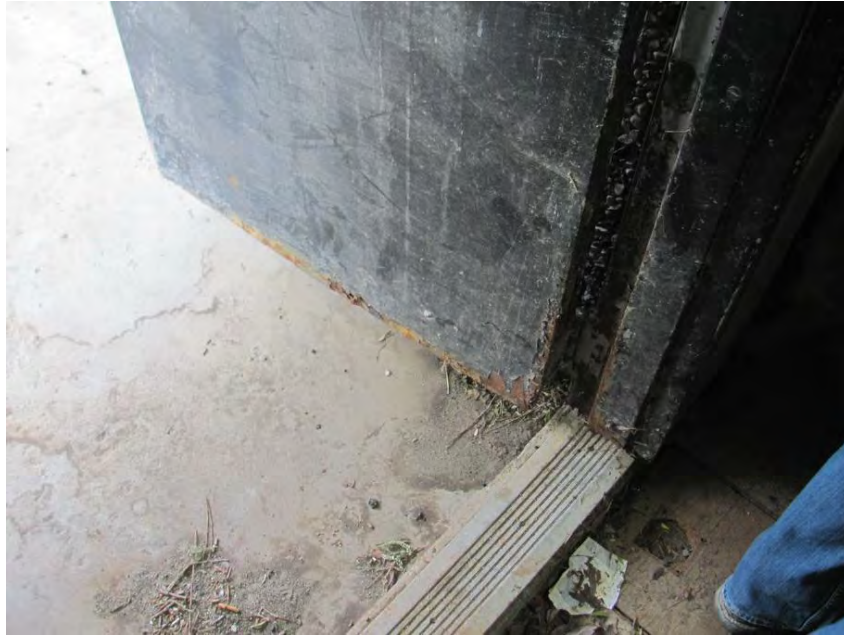
Door-Detail-Exterior

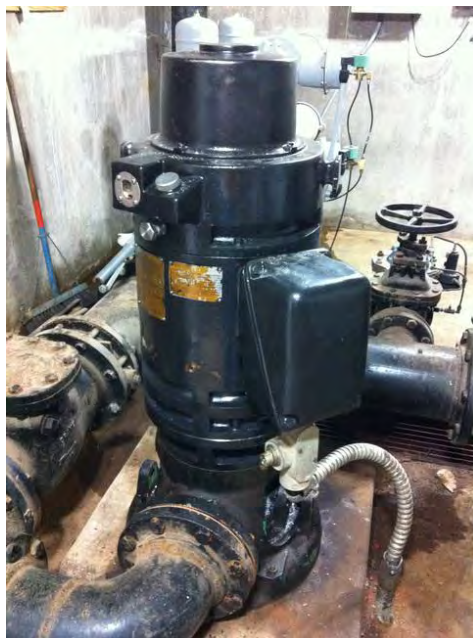
Pump 1 Seal-Detail-Interior

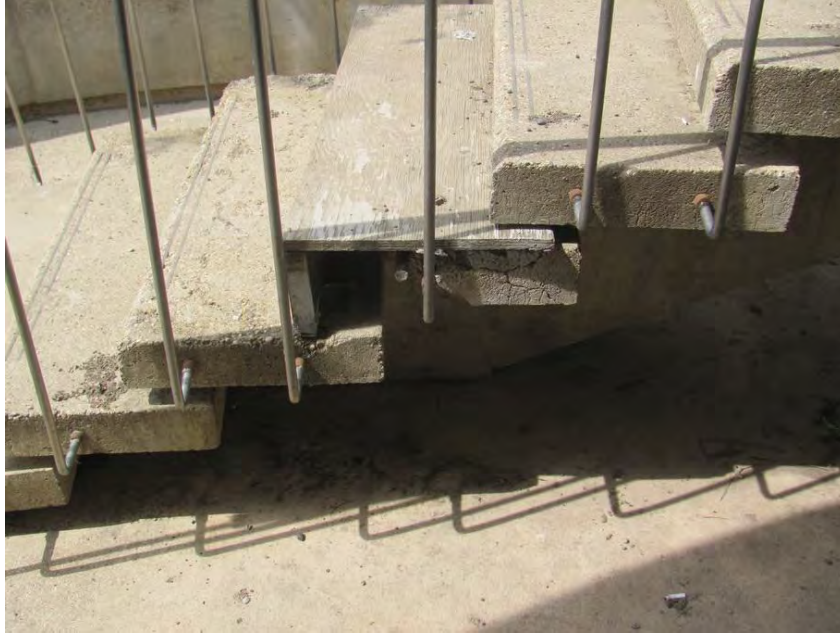
Stair-Detail-Exterior

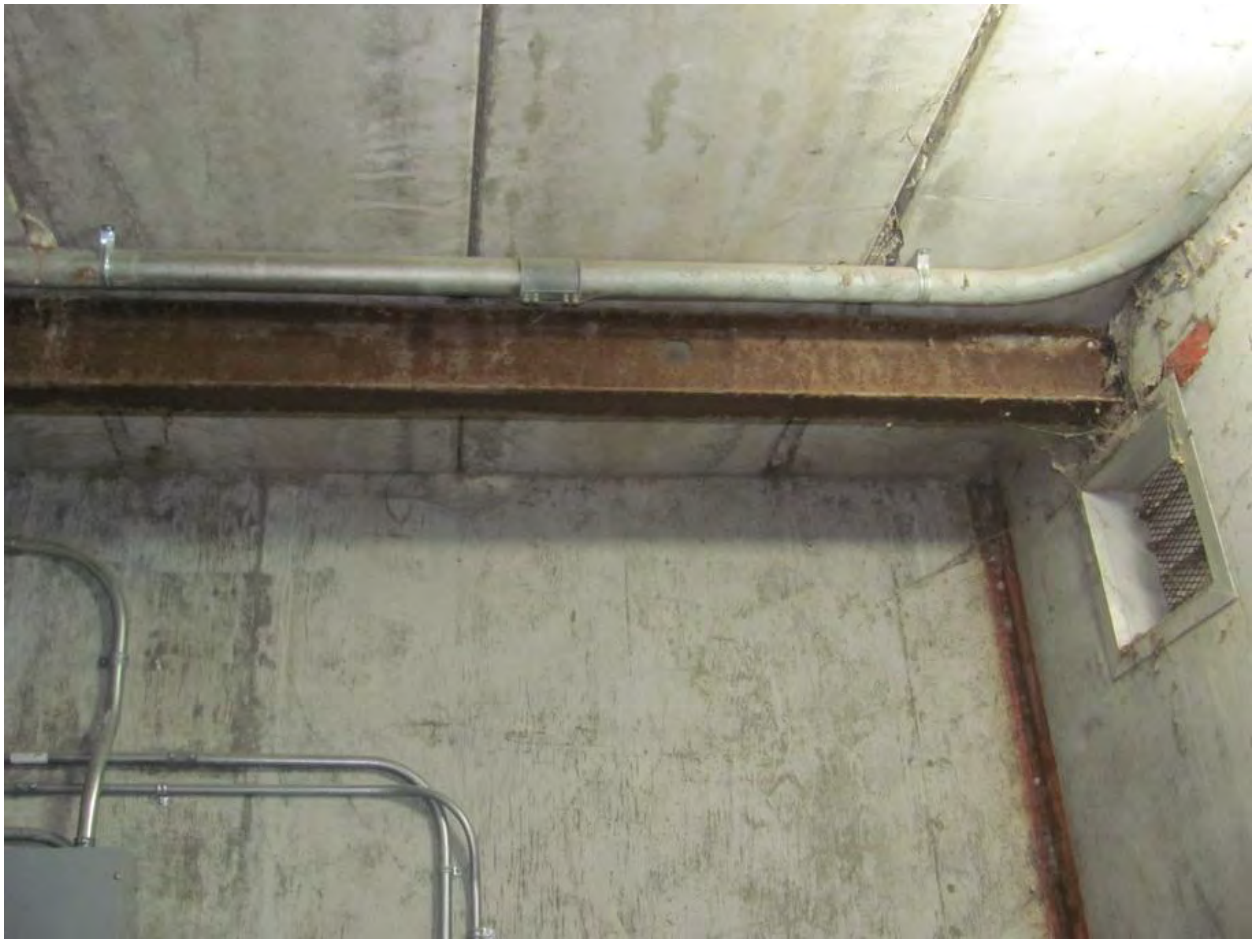
Hoistbeam-Detail-Interior
